(NASA-CR-179839) AN IN-SITU STUDY IN SEM OF
DELAMINATION IN SEVERAL GRAPHITE/EPOXY
COMPOSITE MATERIAL SYSTEMS Annual Progress
Report, 1 Feb. 1985 - 31 May 1986 (Texas A&M
Univ.) 96 p

Annual Progress Report

"An In-Situ Study in SEM of Delamination in Several
Graphite/Epoxy Composite Material Systems"

Walter L. Bradley
Professor of Mechanical Engineering
Texas A&M University
College Station, TX 77843
409-845-1259

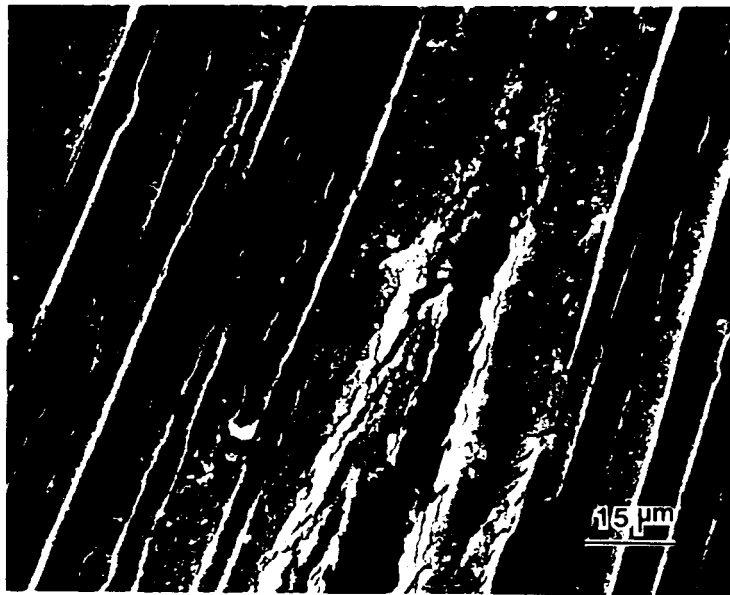
Figure 5. In-situ mode I delamination of T6T145/F185 composite showing microcracking around the crack tip which is film and substrate microcracking. 850X

To illustrate, compare the results for fracture of neat resin Hexcel F185 (Figure 4) to the results for the composite made from this resin T6T145/F185 (Figure 5). The high density microcracking with some indication of surface charging in Figure 4 should be interpreted

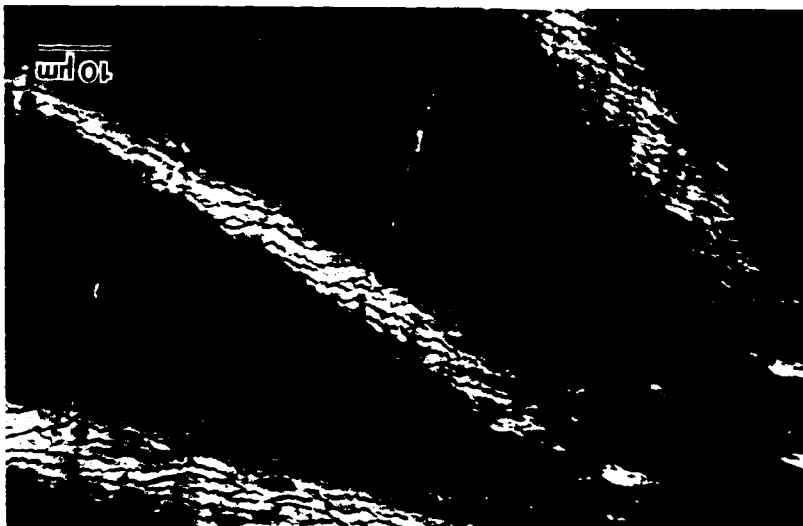
Figure 9. Compact tension specimen of Lexan neat resin (without copel rubber), coated with Au/Pd, and then loaded in-situ in the SEM. The same "wing shaped" damage zone noted in Figure 8 is seen here. However, the primary difference is the appearance of dense microcracking which is clearly in the film rather than the substrate. 9(a) 200X; 9(b) 1000X; 9(c) 2000X; 9(d) 3000X; 9(e) 1000X; 9(f) 1000X.

Subsequently, a miniature compact tension specimen of Lexan was carefully polished, sputter coated with Au/Pd, and then loaded in the SEM. The results are presented in Figure 9 and should be compared to the results previously discussed in Figure 8. The high density of microcracking seen in Figure 9 but absent in Figure 8 is the result of coating microcracking. A few real cracks which have formed in the Lexan are also noted in Figure 9 and are easily distinguished from the more superficial coating microcracks.
